March 2, 2023

RE: Surface Corrosion (Rust) on Structural Steel Shapes

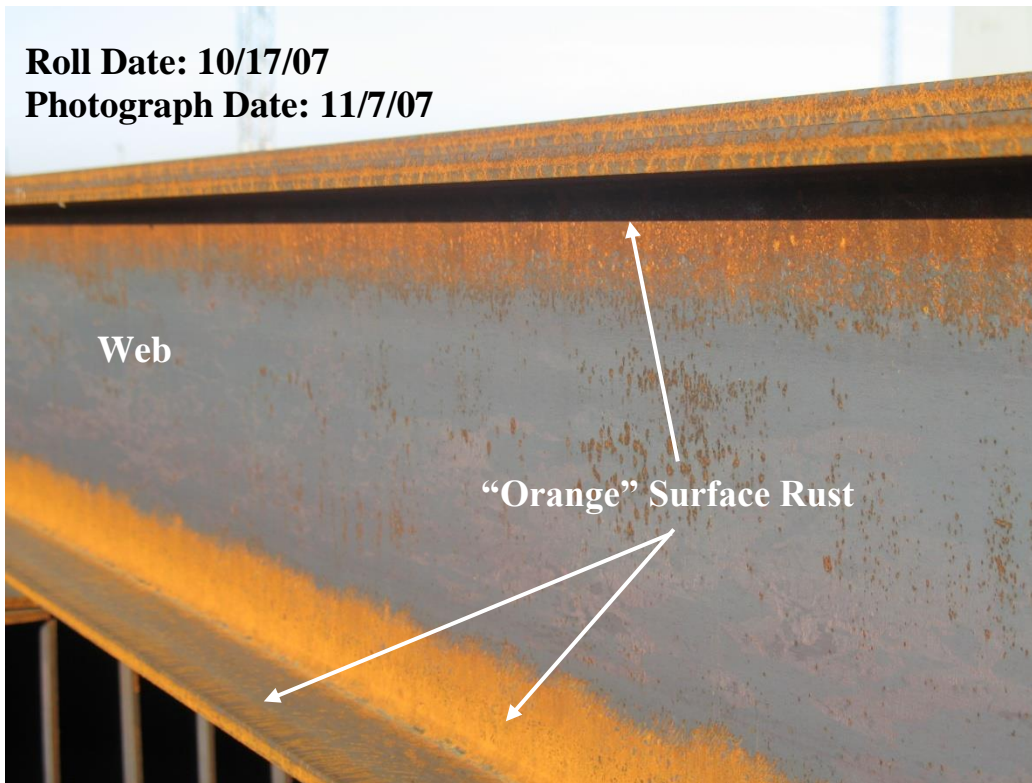
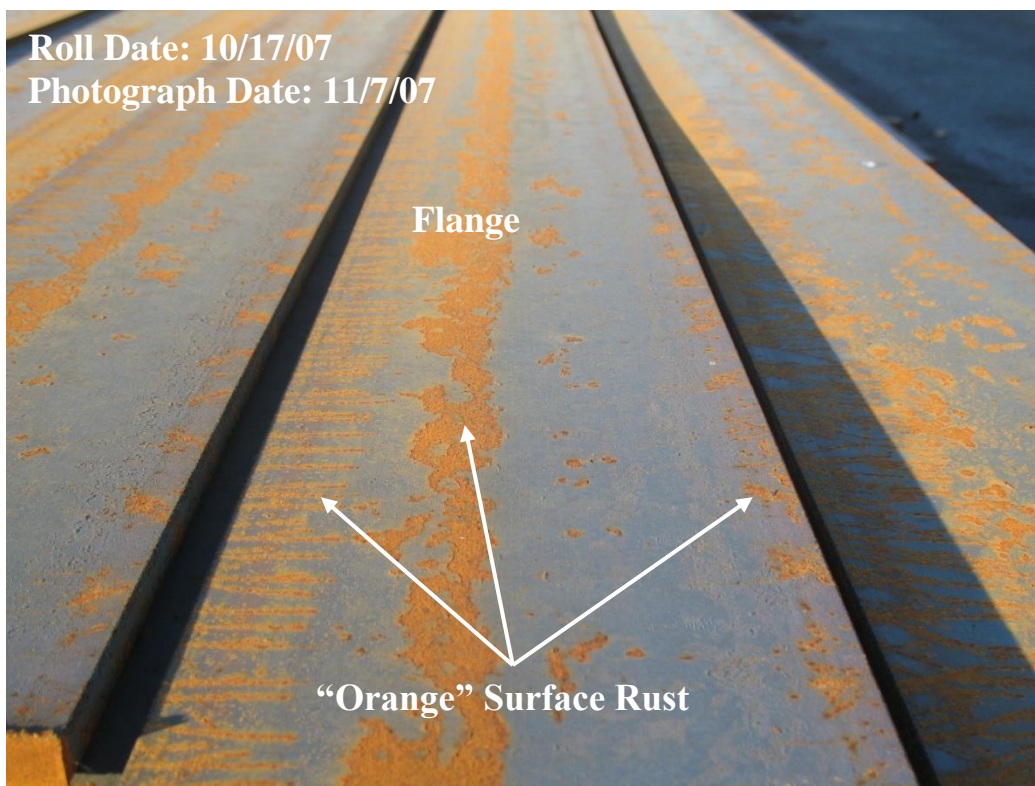
Nucor-Yamato Steel stores the structural steel shapes we produce both inside in one of our warehouses and outside in our yard. Structural steel shapes that are stored outside will begin to form surface corrosion (rust) selectively where the mill scale layer has been removed (see photographs on the next page). This selective corrosion typically occurs on the flanges and the web depending on several production factors. The beams in the photographs were produced on 10/17/07 and stored in one of our outside yards and the photographs were taken on 11/7/07. As the photographs show, there is already an appreciable amount of “orange” surface rust out near the flange toes, on the inside surface of the flanges, and on the web out near the fillet radius after less than one month of being stored in an outside environment.

Unless otherwise specified, structural products are normally furnished in the as-rolled condition and are subjected to visual inspection by the manufacturer or processor. Non-injurious surface or internal imperfections, or both, may be present in the structural product as delivered and the structural product may require conditioning by the purchaser to improve its appearance or in preparation for welding, coating, or other further operations.
