RE: Surface Corrosion (Rust) on Structural Steel Shapes

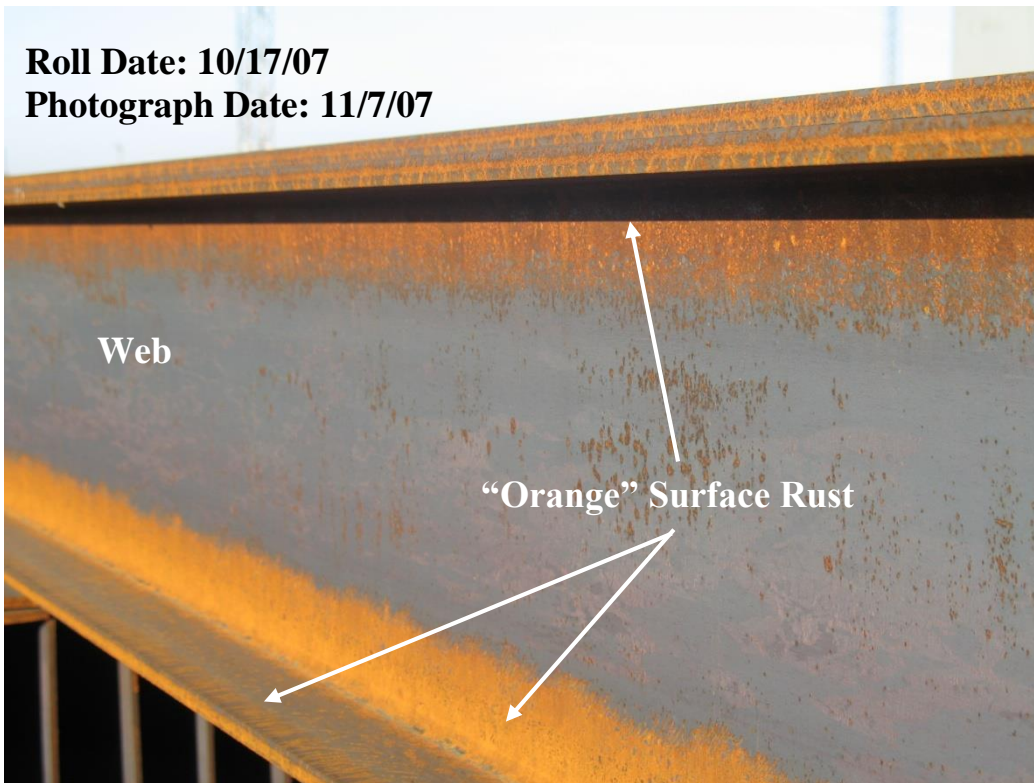
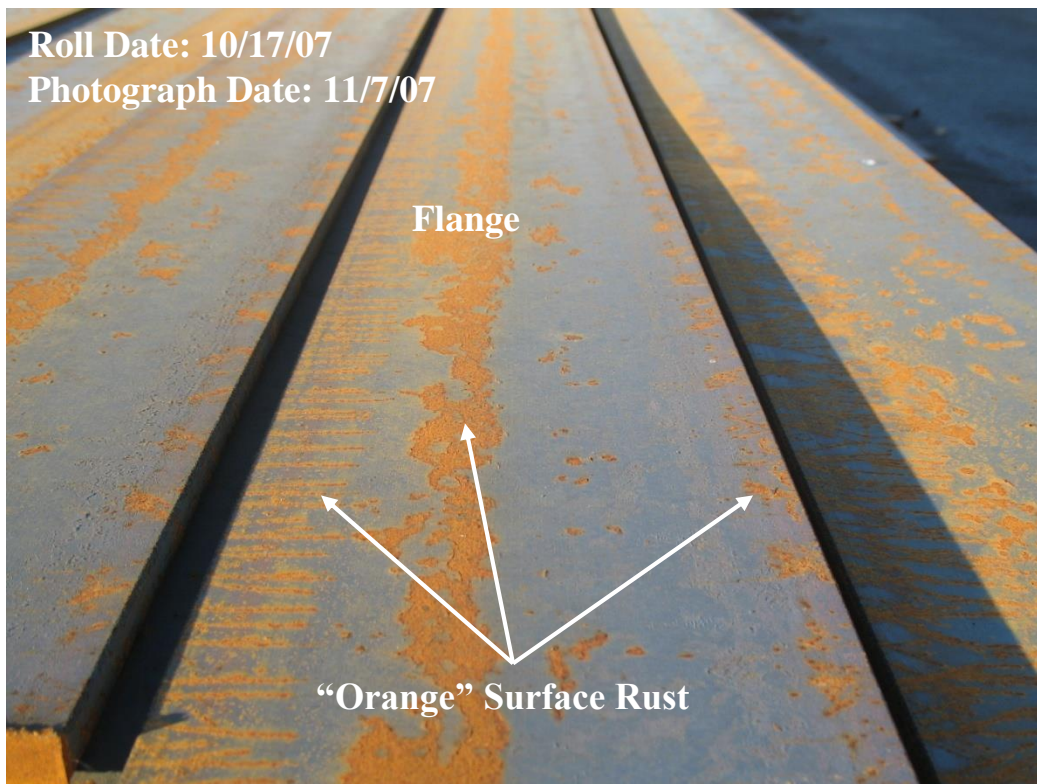
Nucor-Yamato Steel stores the structural steel shapes we produce both inside in one of our warehouses and outside in our yard. Structural steel shapes that are stored outside will begin to form surface corrosion (rust) selectively where the mill scale layer has been removed (see photographs on the next page). This selective corrosion typically occurs on the flanges and the web depending on several production factors. The beams in the photographs were produced on 10/17/07 and stored in one of our outside yards and the photographs were taken on 11/7/07. As the photographs show, there is already an appreciable amount of “orange” surface rust out near the flange toes, on the inside surface of the flanges, and on the web out near the fillet radius after less than one month of being stored in an outside environment.

Unless otherwise specified, structural products are normally furnished in the as-rolled condition and are subjected to visual inspection by the manufacturer or processor. Non-injurious surface or internal imperfections, or both, may be present in the structural product as delivered and the structural product may require conditioning by the purchaser to improve its appearance or in preparation for welding, coating, or other further operations.
