Nucor-Yamato Steel Company
5929 E. State Hwy 18
Blytheville, AR 72315
870.762.5500

RE: Surface Corrosion (Rust) on Structural Steel Shapes

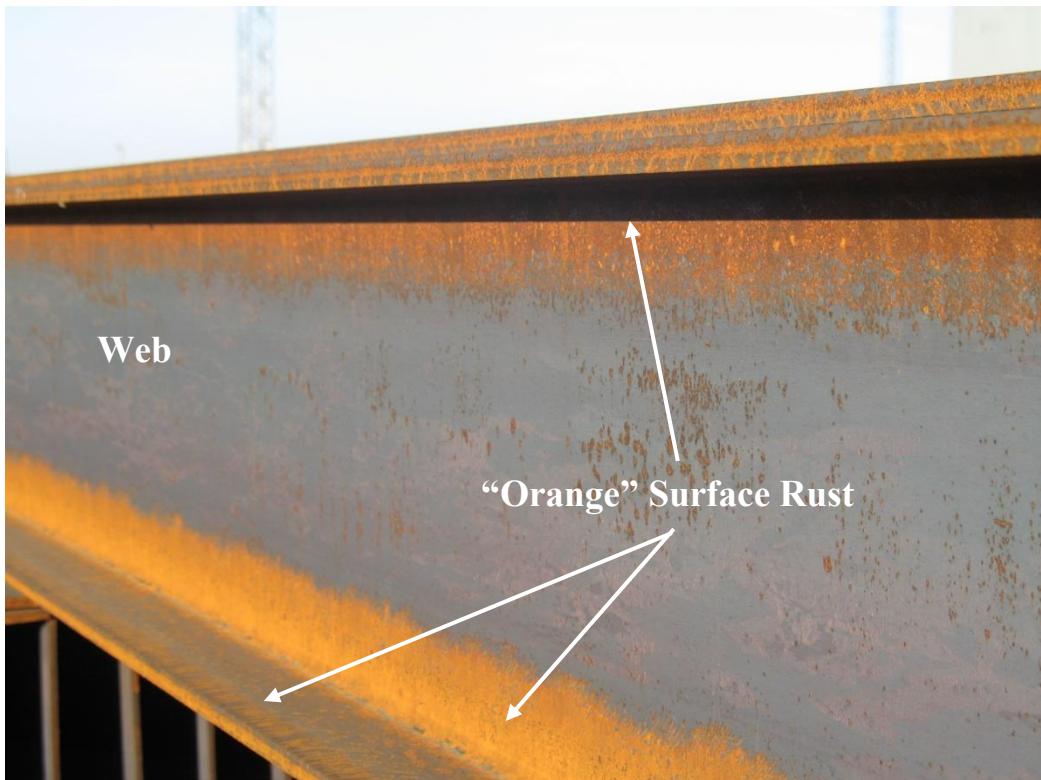
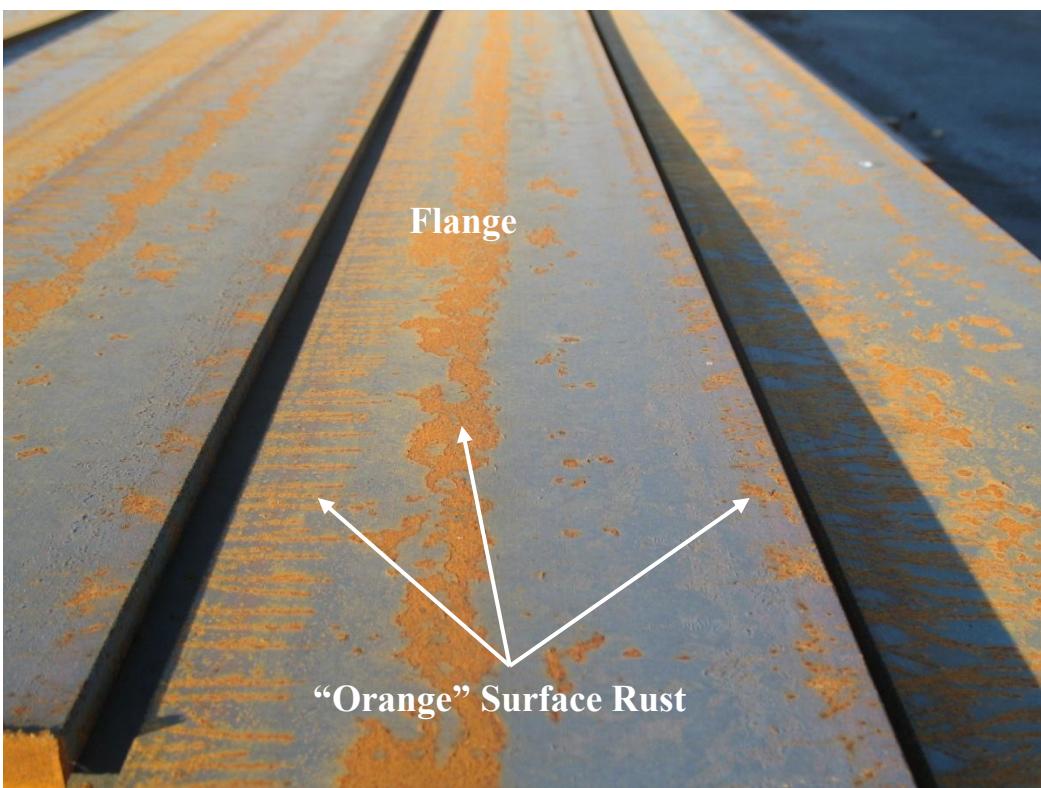
Nucor – Yamato Steel, Co. stores the structural steel shapes we produce both inside in one of our warehouses and outside in our yard. Structural steel shapes that are stored outside will begin to form surface corrosion (rust) selectively where the mill scale layer has been removed (see photographs on the next page). This selective corrosion typically occurs on the flanges and the web depending on several production factors. The photographs below were taken just one month after the beams had been produced and had been stored in one of the outside yards at Nucor – Yamato Steel, Co. As the photographs show, there is already an appreciable amount of “orange” surface rust out near the flange toes, on the inside surface of the flanges, and on the web out near the fillet radius after just one month of being stored in an outside environment.

ASTM A6/A6M, the general requirements specification for rolled structural steel bars, plates, shapes, and sheet piling, states in Section 9.1 Note 5:

Unless otherwise specified, structural products are normally furnished in the as-rolled condition and are subjected to visual inspection by the manufacturer or processor. Non-injurious surface or internal imperfections, or both, may be present in the structural product as delivered and the structural product may require conditioning by the purchaser to improve its appearance or in preparation for welding, coating, or other further operations.
