**Nucor-Yamato Steel Co.**

**RE: Surface Corrosion (Rust) on Structural Steel Shapes**

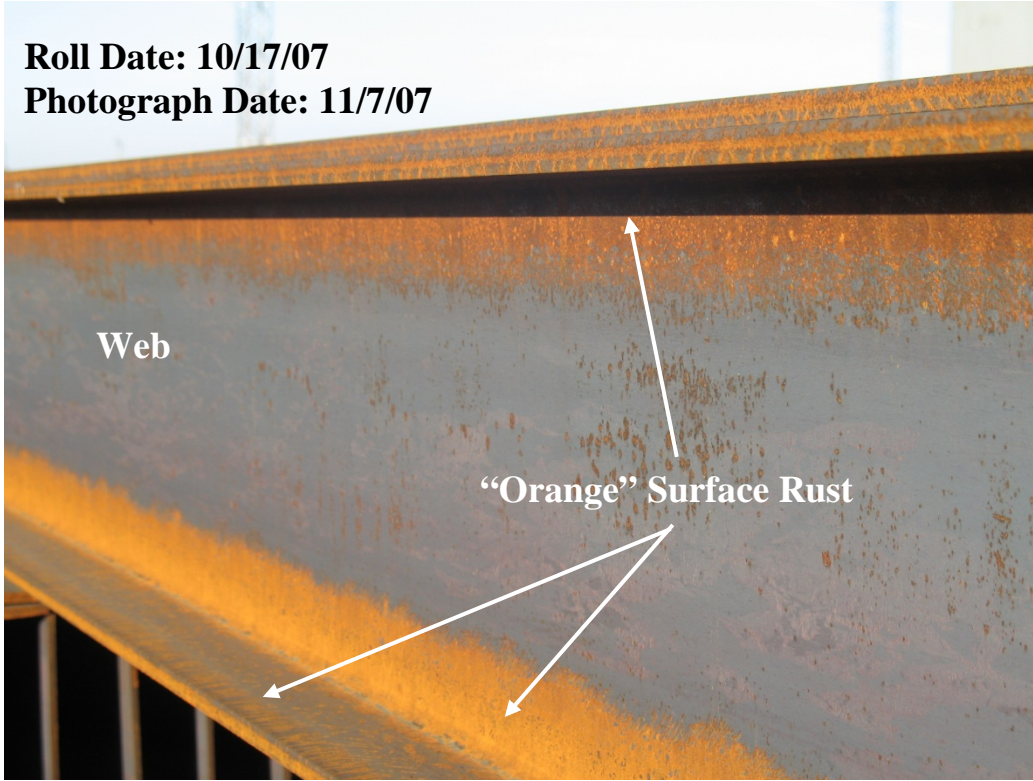
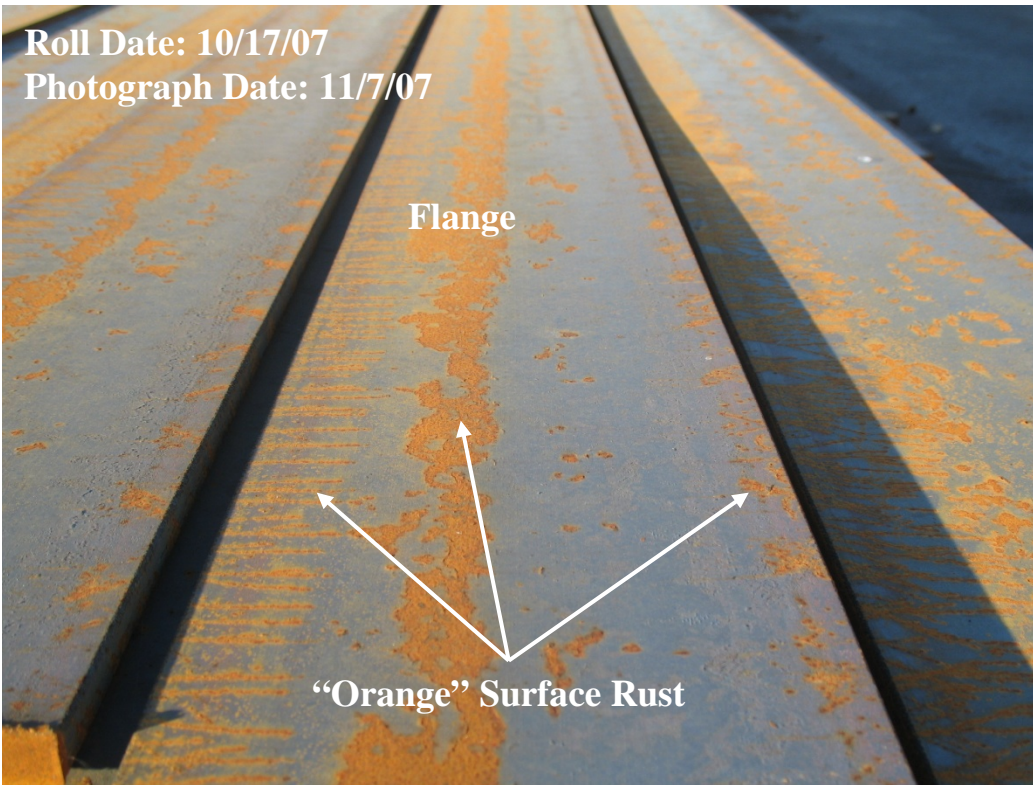
Nucor-Yamato Steel stores the structural steel shapes we produce both inside in one of our warehouses and outside in our yard. Structural steel shapes that are stored outside will begin to form surface corrosion (rust) selectively where the mill scale layer has been removed (see photographs on the next page). This selective corrosion typically occurs on the flanges and the web depending on several production factors. The beams in the photographs were produced on 10/17/07 and stored in one of our outside yards and the photographs were taken on 11/7/07. As the photographs show, there is already an appreciable amount of “orange” surface rust out near the flange toes, on the inside surface of the flanges, and on the web out near the fillet radius after less than one month of being stored in an outside environment.

*Unless otherwise specified, structural products are normally furnished in the as-rolled condition and are subjected to visual inspection by the manufacturer or processor. Non-injurious surface or internal imperfections, or both, may be present in the structural product as delivered and the structural product may require conditioning by the purchaser to improve its appearance or in preparation for welding, coating, or other further operations.*
