Nucor-Yamato Steel Co.

RE: Surface Corrosion (Rust) on Structural Steel Shapes

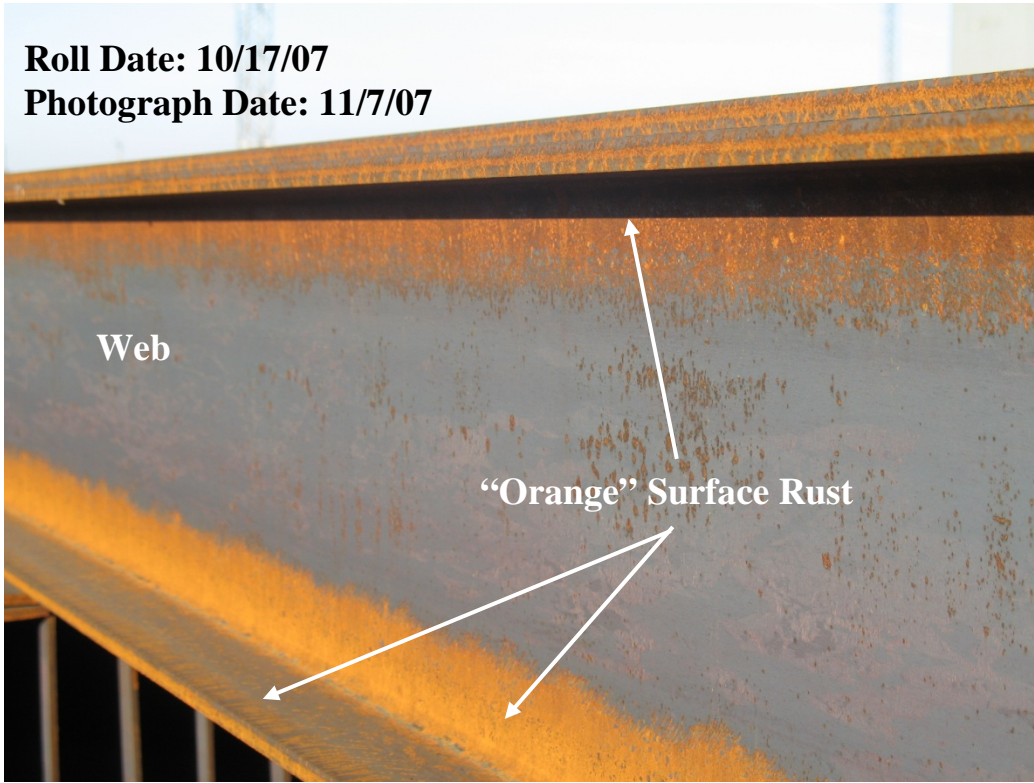
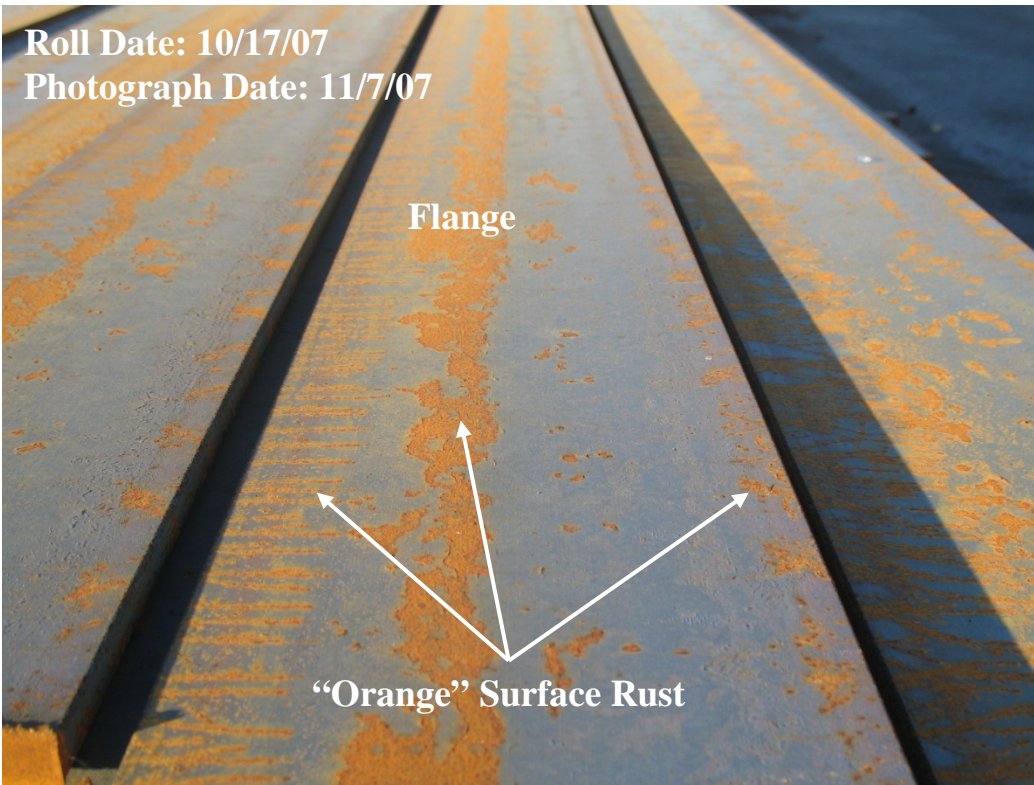
Nucor-Yamato Steel stores the structural steel shapes we produce both inside in one of our warehouses and outside in our yard. Structural steel shapes that are stored outside will begin to form surface corrosion (rust) selectively where the mill scale layer has been removed (see photographs on the next page). This selective corrosion typically occurs on the flanges and the web depending on several production factors. The beams in the photographs were produced on 10/17/07 and stored in one of our outside yards and the photographs were taken on 11/7/07. As the photographs show, there is already an appreciable amount of “orange” surface rust out near the flange toes, on the inside surface of the flanges, and on the web out near the fillet radius after less than one month of being stored in an outside environment.

Unless otherwise specified, structural products are normally furnished in the as-rolled condition and are subjected to visual inspection by the manufacturer or processor. Non-injurious surface or internal imperfections, or both, may be present in the structural product as delivered and the structural product may require conditioning by the purchaser to improve its appearance or in preparation for welding, coating, or other further operations.
